**Greenville Water Table Rock
New Intake Inspection
Inspection Conducted On:
January 24, 2019**

Intake Inspection Report

Greenville Water Table Rock New Intake

Inspection Date January 24, 2019

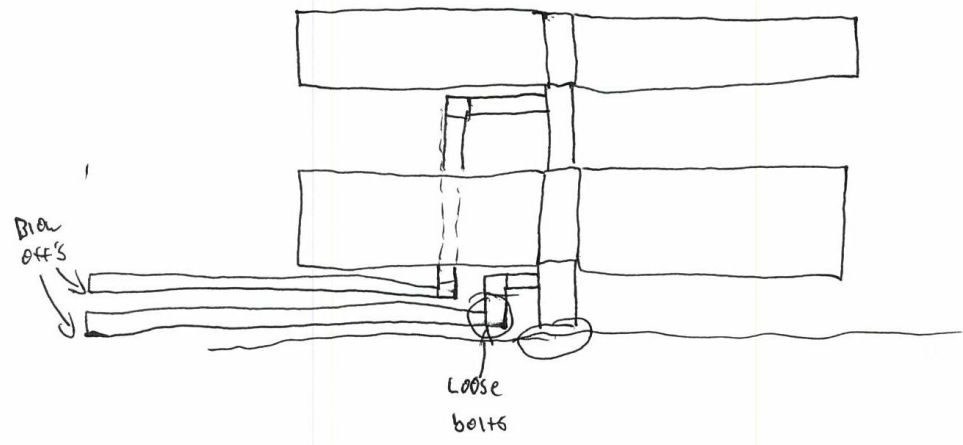
DRAWING(s):

- Description: 2 Johnson T screens w/ blow off
- Accessibility In lake boat required
- Distance water level to entry N/A
- Exterior Walls: N/A
- Exterior Ladder (Security/Fall protection): N/A
- Entry Hatch N/A
- Man Entry (exterior) N/A
- Trash Racks: N/A
- Screens (No., Type, Size) 10' diameter 40' long Stainless Steel Johnson T screens
- Sediment on exterior (aprons, in front of screens) (Depth, composition);
light Algae buildup
- Operators: Make, Serial numbers, Operation: N/A

Notes / Recommendations Hardware on blow off flange needs to be tightened
